Grout Acidification of Ribbon Anode in Impressed Current Cathodic Protection Systems in Concrete Structures

Abstract

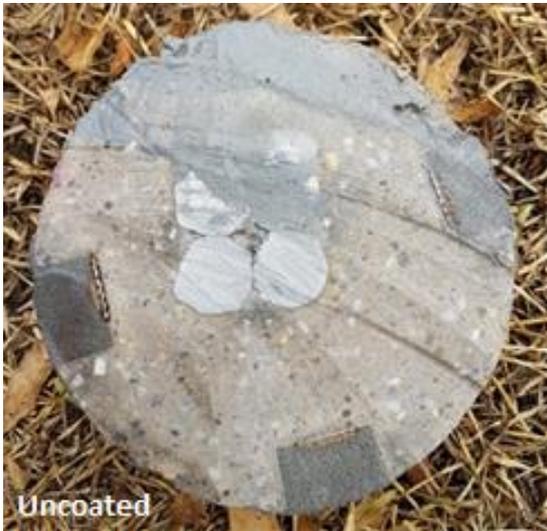
The visual results revealed similar levels of acidification around the anodes in both samples. There was no evidence that water had penetrated to the ribbon anode, via a crack or defect in both the coated and uncoated cylinders. Due to the lack of localised water ingress, the acidification around the anode was found to be uniform along the length of the ribbon anode. This type of acidification is caused by high current density due to the accelerated testing. The visual inspection also revealed that grout acidification occurred at the anode/grout interface, and the concrete had not visually degraded from the acidification.

Figure 5 – Experiment 1, uncoated sample

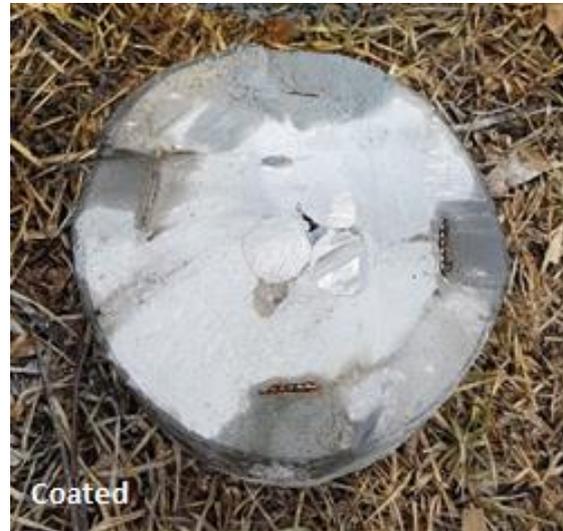
Figure 6 – Experiment 1, coated sample

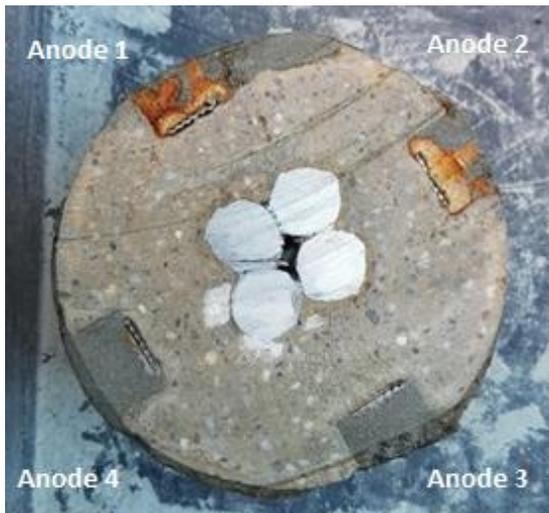
It was evident that the increased level of acidification at the point of water ingress greatly increased the level of grout deterioration as seen in Fig. 7 anodes 1 and 2. In Fig. 7, there is minimal acidification around anodes 3 and 4 where a cementitious waterproofing coating was applied on the external slot cut surface. Fig. 8 shows that all anodes located above water level exhibited minimal grout acidification.

Figure 7 – Experiment 2, cross section of sample at the point of water ingress below water level

The aim of experiment 2 was to test the performance of the cementitious waterproofing coating in providing protection and stopping the ingress of water to the anode with the incorporation of a standardised and uniform defect between the test anodes. A dissection of the concrete sample was carried out after the 38-day experiment. Two images Figs. 7 and 8 were taken after the dissection of the concrete sample; Fig. 7 showing the drilled location, under the water level, at the point of water ingress to the anode, and Fig. 8 above the water level.

- Localised water ingress to the anode can greatly affect the level of acidification and grout deterioration around the anode.
- A 2.5 mm thick layer of cementitious waterproofing coating provided protection to the anode from direct water ingress, as shown in Fig. 7 anodes 3 and 4.
- Where water ingress does reach the anode, as shown in Fig. 7 anodes 1 and 2, a considerable level of grout acidification was evident.
- In locations where the anode was not exposed to direct water ingress as in Fig. 8, the level of grout acidification was minimal.
- There was no visual evidence of acidification causing deterioration of the existing parent concrete surface. All acidification witnessed during the experiment was of the encapsulating grout material.
