MARCH 2018
VOL. 57, NO. 3

PROTECTING CONCRETE WHARVES WITH CATHODIC PROTECTION

Protecting Concrete Wharves with Cathodic Protection

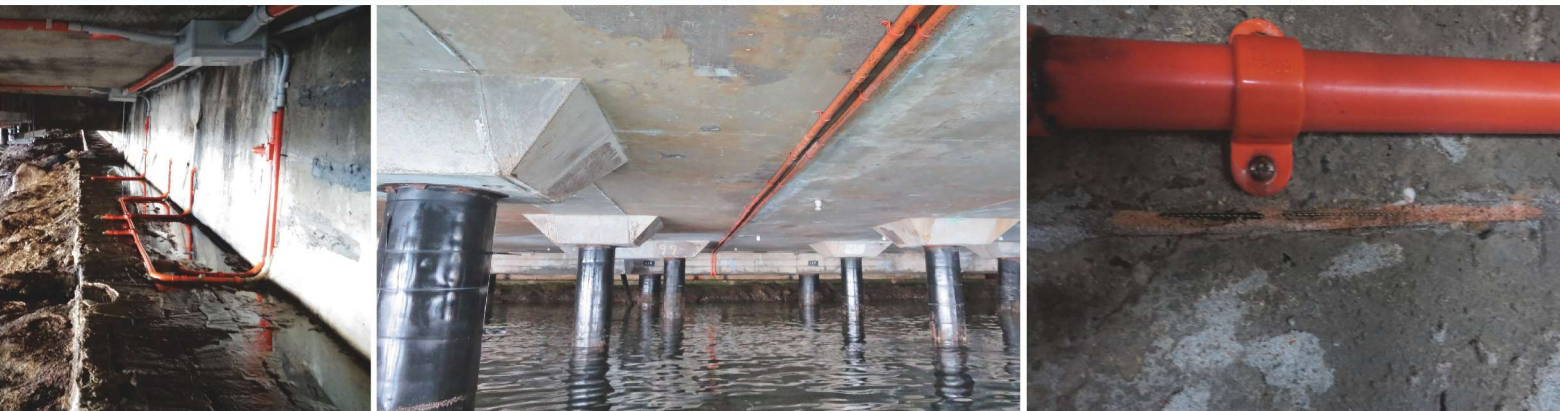
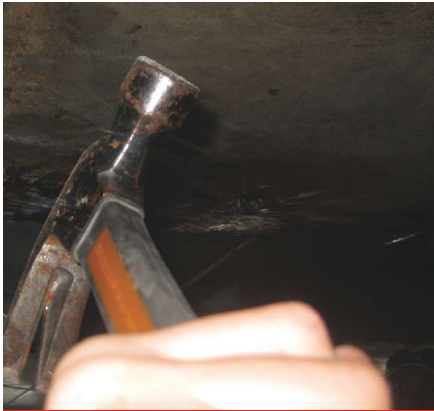
It took a crew of six people, accessing the structure by boat and land, about two weeks to hammer test the entire concrete surface underneath the wharf. Photo courtesy of Atef Cheaitani.

Hammer tests were performed to check for concrete delamination. The entire concrete area—8,000 m²—was tested. Some areas (usually in the front and rear crane beams) produced a hollow sound when struck by the hammer, and were marked as potential delamination areas.

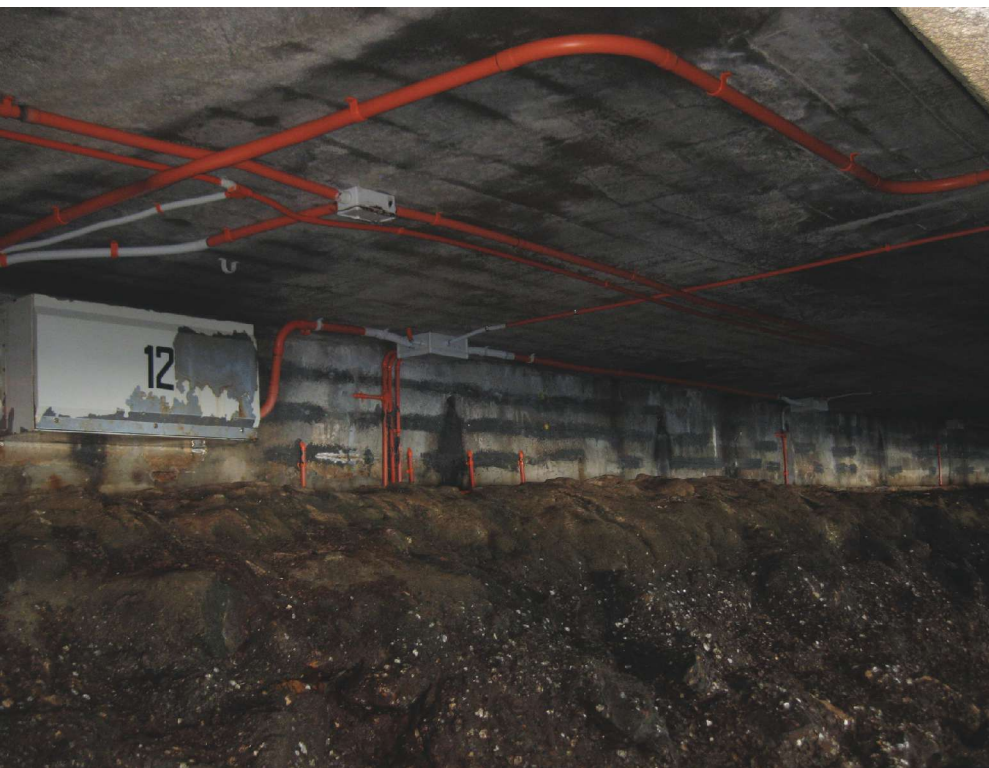
A control unit installed underneath the wharf was part of the original ICCP system. Photo courtesy of Atef Cheaitani.

Components with varying degrees of water damage were noted for many of the junction boxes and control units located at the abutment wall underneath the wharf. At the time of system installation, enclosures rated as IP67 were thought to be sufficient for providing protection to all components within the enclosures against

moderate water exposure at high tide. However, ~50% of the control units and 50% of the junction boxes located at the abutment wall in an area with water exposure had some sort of water damage to terminals and electronics inside. The audit found, though, that 96 junction boxes located at the front crane beam and away from the water were in excellent condition.

The scope of the renovation work was to move the junction boxes and control units to locations above the wharves while maintaining and utilizing all embedded CP system components in the concrete (ribbon anodes, reference electrodes, and cabling). While developing the configuration for this task, Cheaitani explored increasing the size of the ICCP zones and reducing the number of circuits in the existing system. This could be possible because an analysis of system

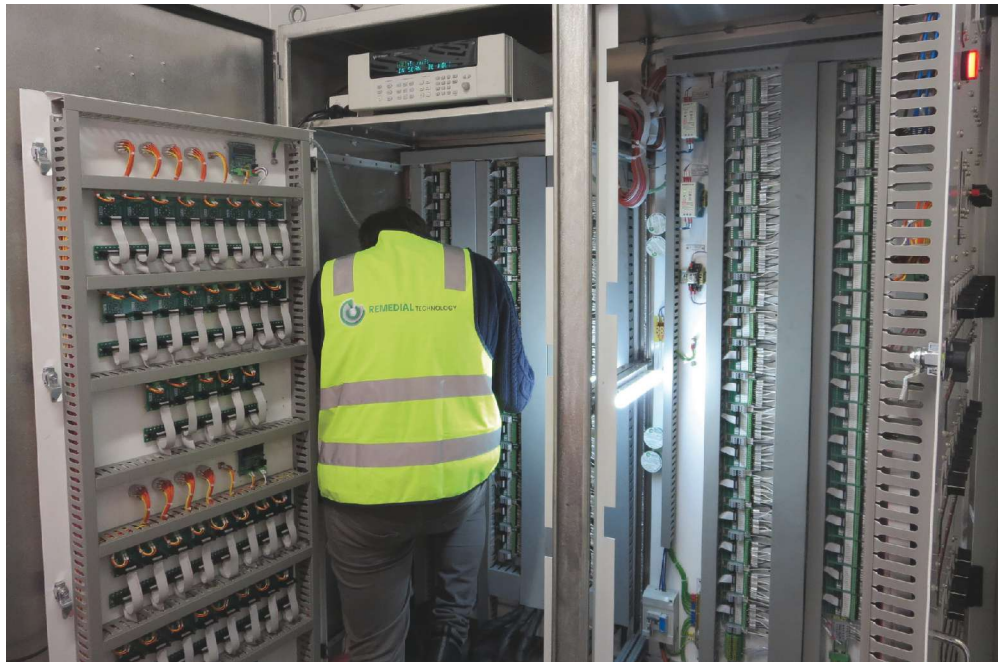
New control units were installed in a climate-controlled room above the wharves. Photo courtesy of Atef Cheaitani.

The new system design eliminated the installation of electronics underneath the wharf, and required less cabling. The overall number of circuits was reduced from 14 to 8 in each typical section, and the number of sections was decreased from a total of 13

localized control units underneath the wharves to six control units all located in a central climate-controlled room above the wharves. This resulted in a total reduction in the number of circuits—from 172 to 48. Cable design and voltage drop calculations were performed for all cables between the structure and the new location of the controller units, and different sized cables, from 4 to 16 mm, were used between the junction boxes at the wharves and the new locations of the control units to ensure proper current delivery to all system zones.

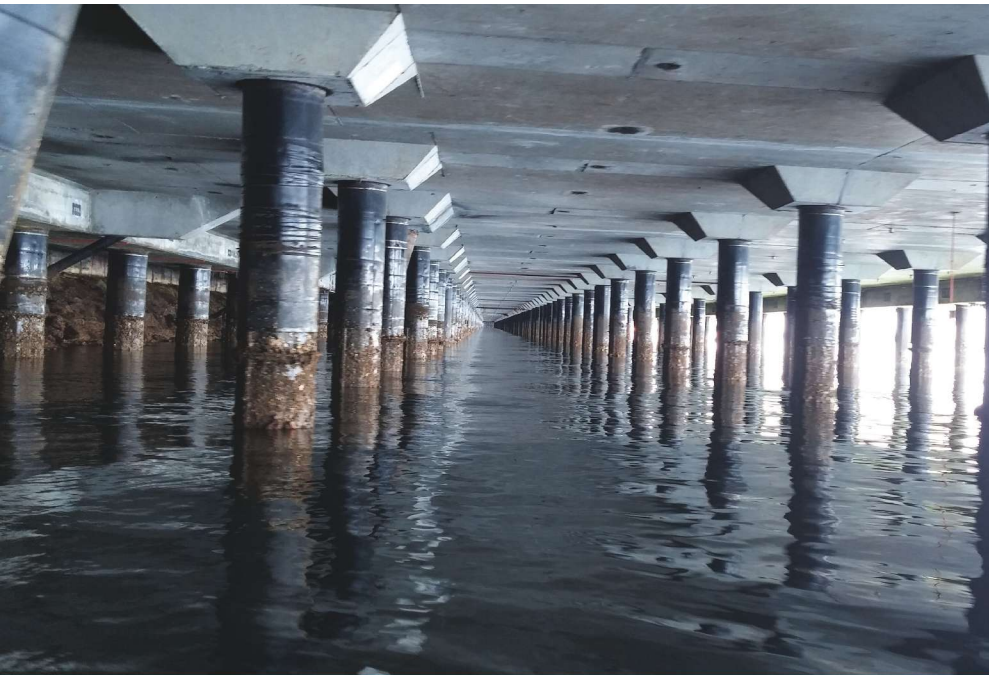
The approximate concrete area underneath Wharves 4 and 5 that is protected by the ICCP system is 8,000 m². Photo courtesy of Atef Cheaitani.
